# Matters of National Environmental Significance Management Plan

## **Meteor Downs South Coal Project**

Sojitz Blue Pty Ltd

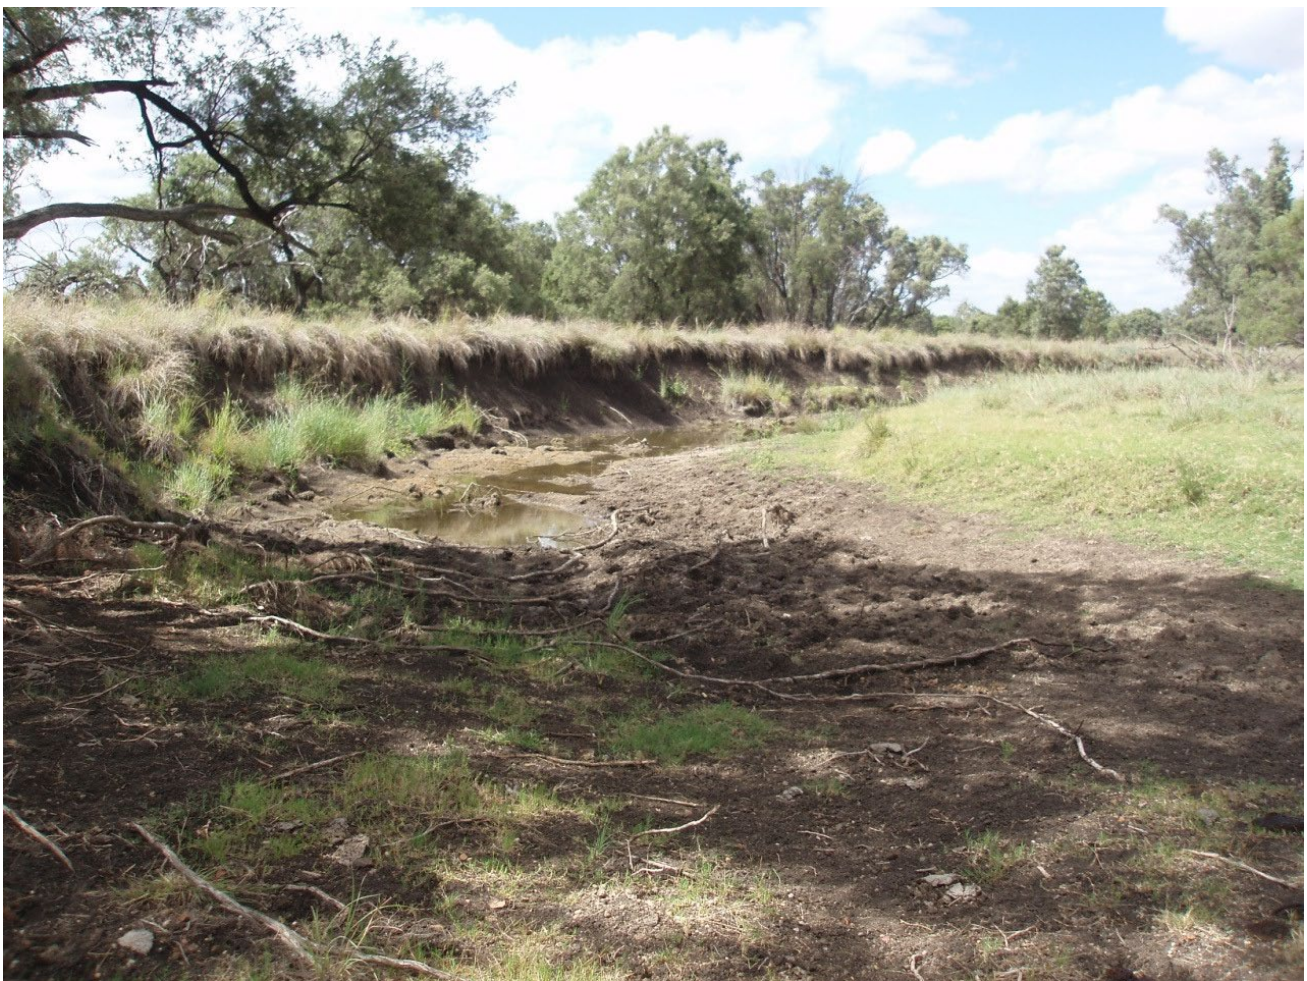
**Plate 1: Spring Creek Channel in Vicinity of the Project site**

Spring Creek is an ephemeral creek which flows only after rainfall events. However, some shallow waterholes may persist after the flow ceases. The portion of the Spring Creek channel located adjacent to the Project area is generally clear of vegetation with some small stands of trees located along the banks and within the channel. Significant erosion is present due to stock accessing the creek for water impacting the soils. The dominant land use within this section of the Spring Creek catchment is low intensity grazing (Plate 1). The ecological assessments undertaken for the Project (CQU 2012 and Ecosure 2013) did not identify Spring Creek as potential habitat for any MNES.

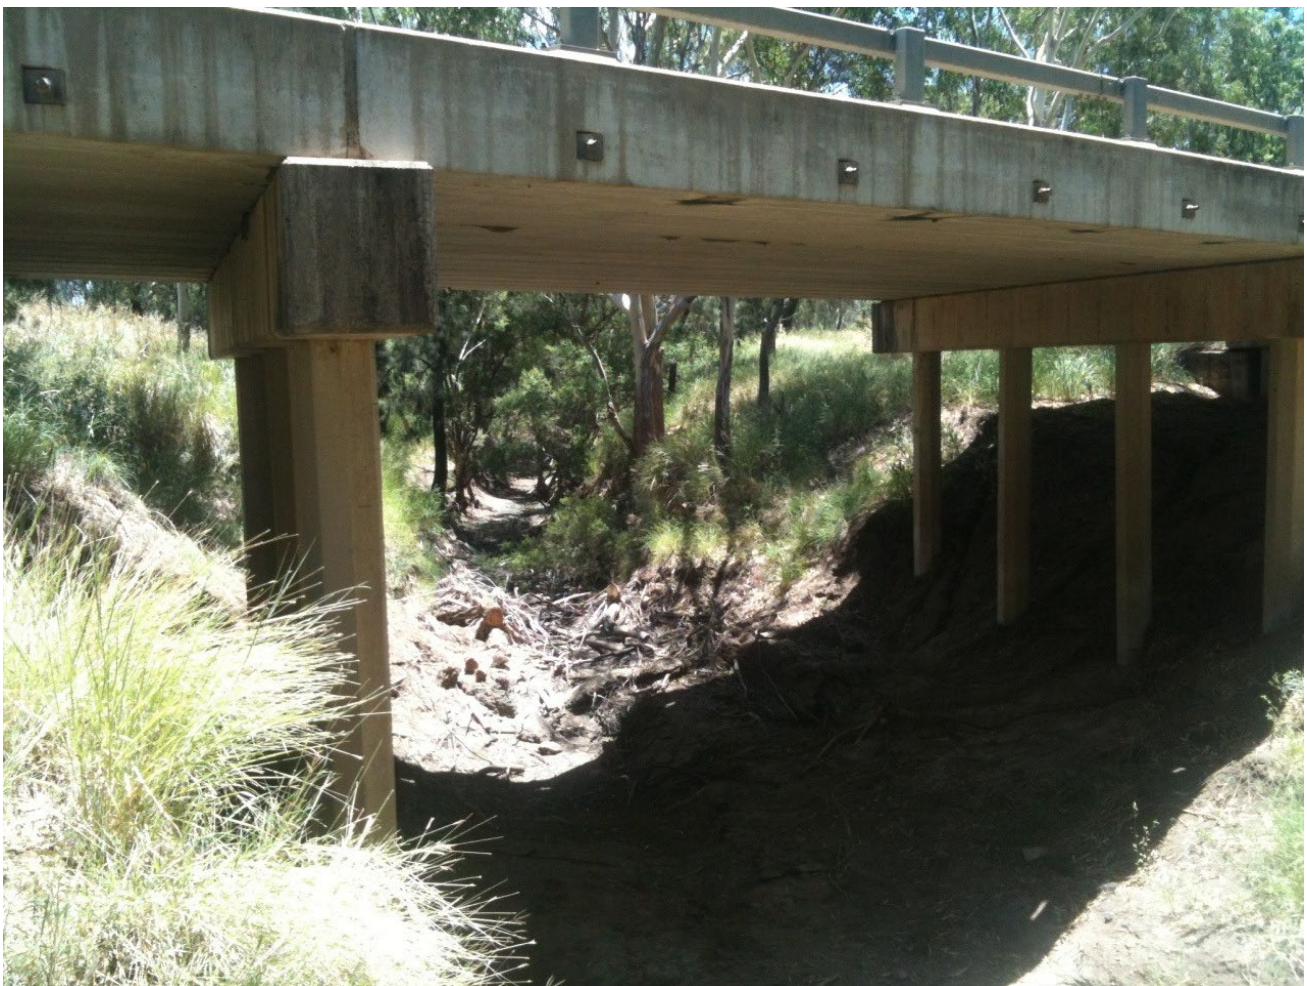
**Plate 2: Aldebaran Creek channel at the Dawson Highway**

The northern portion of the Project site, including the access road is situated within the catchment of Aldebaran Creek. Aldebaran Creek is located to the north and east of the Project site and flows in a north-easterly direction, crossing the Dawson Highway, then changing to a south-easterly direction and draining into Meteor Creek approximately 17 km downstream of the highway. Aldebaran Creek is an ephemeral creek which flows only after rainfall events. However, some shallow waterholes may persist after the flow ceases. The Aldebaran Creek channel is well vegetated with a sandy bed. The dominant land use within the Aldebaran Creek catchment is low intensity grazing, with the creek considered a watering point on stockroute PO42, which runs alongside the Dawson Highway (Plate 2). The ecological assessments undertaken for the Project (CQU 2012 and Ecosure 2013) did not identify Aldebaran Creek as potential habitat for any MNES.

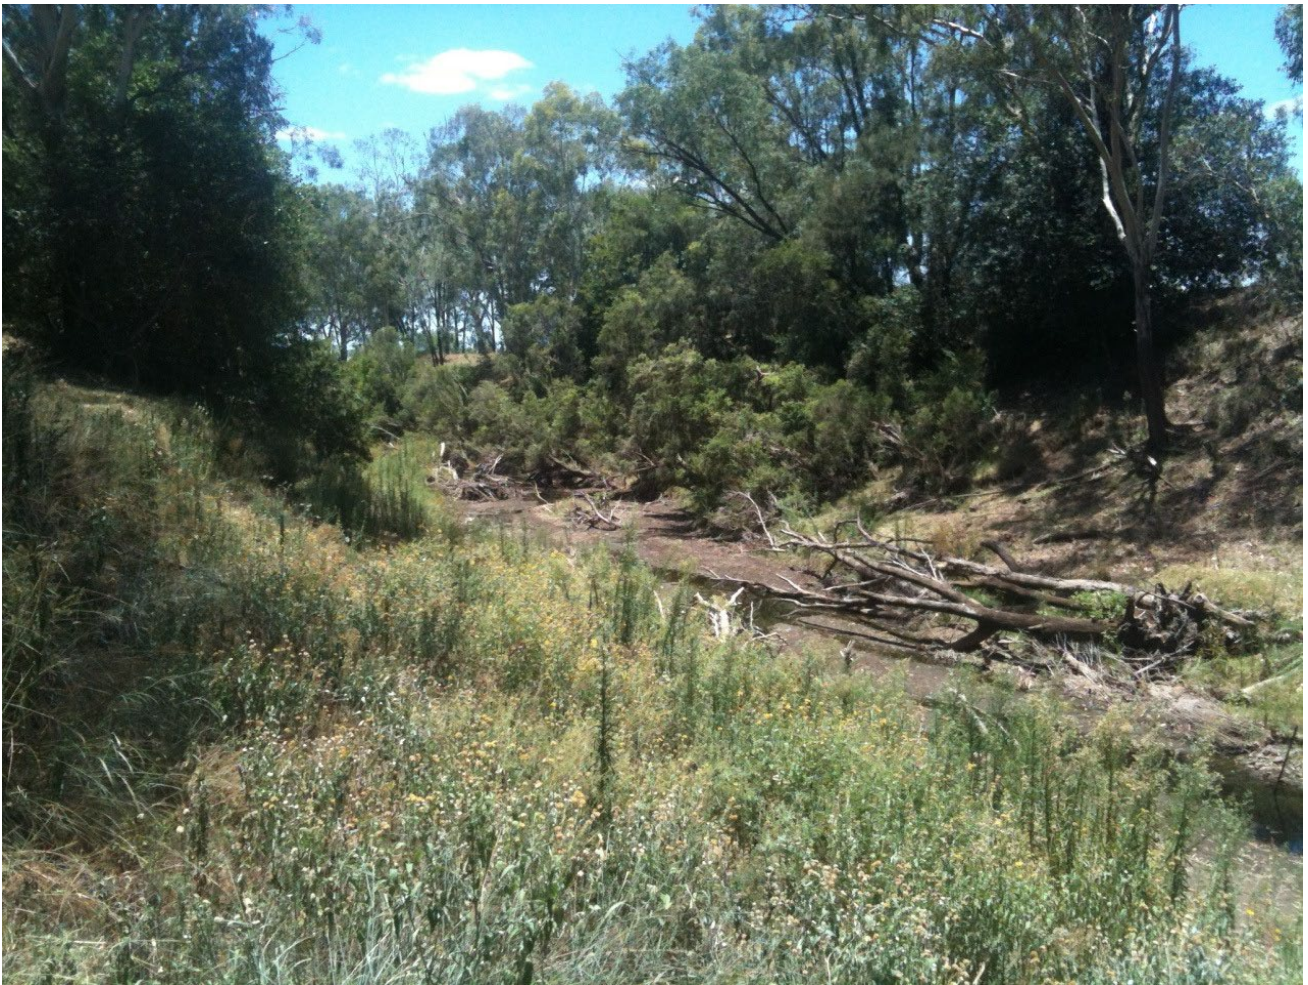
**Plate 3: Meteor Creek channel at Dawson Highway**

Spring Creek and Aldebaran Creek flow into Meteor Creek. Meteor Creek bisects the neighbouring Rolleston Coal Mine lease, flowing in a north-easterly direction draining into the Comet River approximately 14 km from the Dawson Highway. The Meteor Creek catchment area constitutes approximately 9% of the Comet River catchment upstream of the Mackenzie River. Meteor Creek is an ephemeral creek which flows only after rainfall events. However, some shallow waterholes may persist after the flow ceases. The dominant land use within the Meteor Creek catchment is low intensity grazing and conservation (National Park). Meteor Creek has a gravelly bed with well vegetated banks (Plate 3).

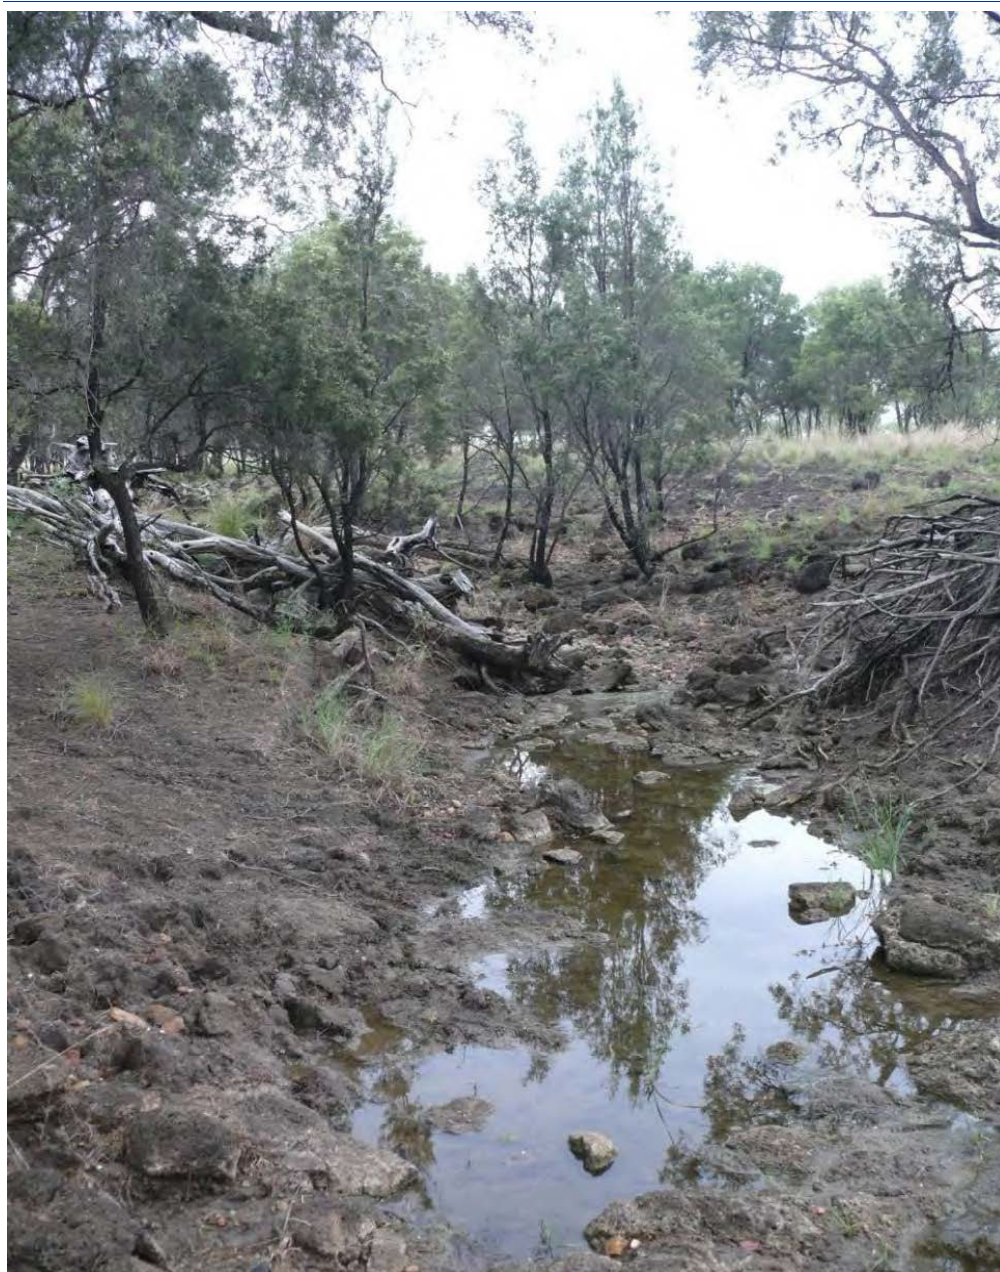
**Plate 5: Creek 1 Upstream (November 2012, after significant rainfall event)**

There are several ephemeral drainage lines present in the Project site. Some of these could provide potential habitat for Australian painted snipe after inundation events (Figure 8). The drainage features within the Project site are generally well defined and although modified by access for stock watering, generally have some vegetation along the banks (see Plate 5 to Plate 10). In the upper portions of the drainage feature catchments, the channels are steep, often with exposed rock in the bed (refer to Plate 5). In the lower parts of the catchment, the drainage feature channels are sandy, with signs of significant erosion (refer to Plate 6). The drainage feature channels at the Project site are typically between 5 m and 10 m wide, and up to 1 m deep. There are numerous minor overland flowpaths evident at the Project site, typically characterised by small gullies and rills draining into the major drainage features.

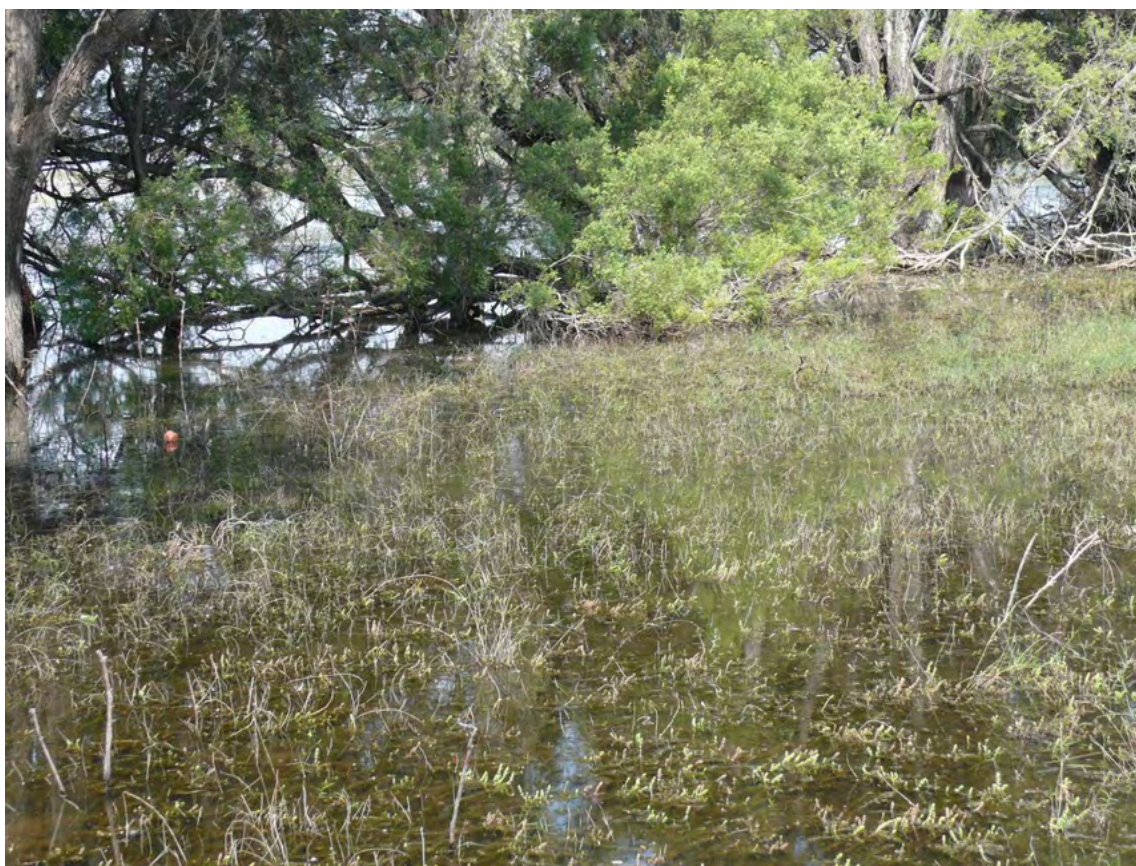
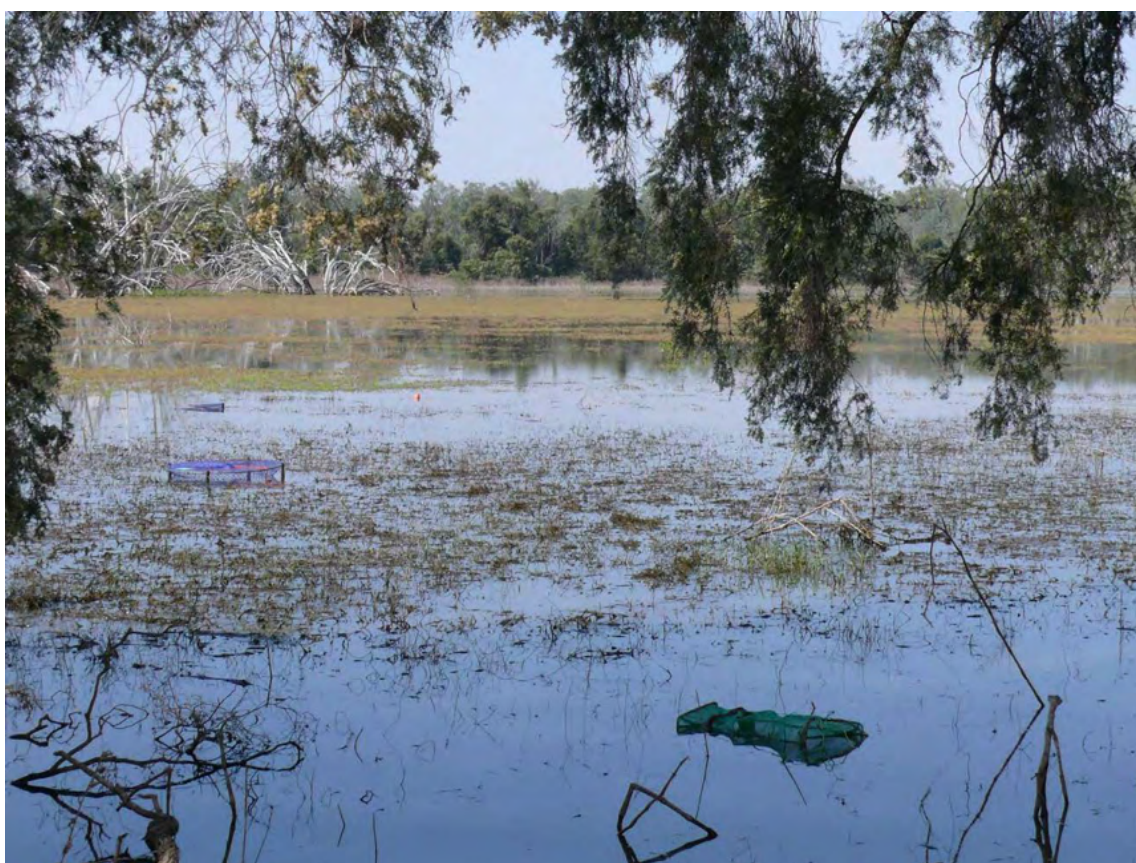
**Plate 11: Naroo Dam edge (November 2012, after significant rainfall event)**

**Plate 12: Naroo Dam (November 2012, after significant rainfall event)**

The mine is within the catchment draining to Naroo Dam. Naroo Dam is located on the eastern side of the Project area (Figure 8, Plate 11 and Plate 12). It is a human-made water storage with a capacity of approximately 750 ML. As discussed in Section 3.1.1 no part of the dam is included in the MDS ML, and all the dam, including the embankment and spillway now lie to the east of the Project boundary. The Naroo Dam spillway has a crest level of 243.78 m AHD. The area of inundation due to the dam extends into the Project mining lease when water levels in the dam exceed approximately 242.0 m AHD. Based on available survey information, the crest of the Naroo Dam embankment appears to be approximately 246.0 m AHD. Naroo Dam is approximately 5.78 m deep at the deepest point, however the depth of the inundation area located within the Project site is less than 2m. Naroo Dam is currently used as a mine water supply source by Rolleston Coal Mine.
