Matters of National Environmental Significance Management Plan Annual Report 2019/2020 Meteor Downs South Coal Project

EPBC 2013/6799

Sojitz Blue Pty Ltd

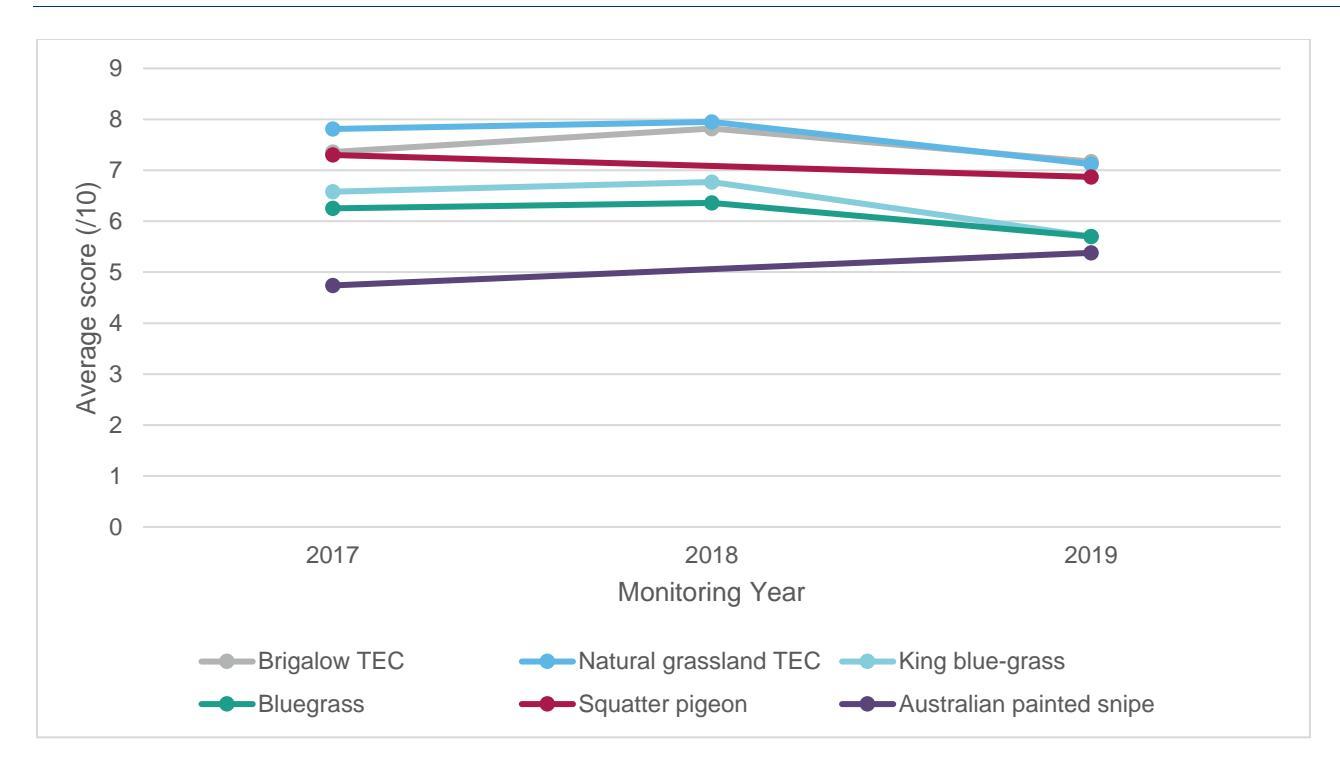
Figure 7: Changes in habitat quality scores for MNES between 2017 and 2019

The habitat quality scores for all MNES, with the exception of the Australian painted snipe, declined in 2019. The decline is most notable in the threatened ecological communities (i.e. Brigalow TEC and natural grassland TEC) and threatened flora (i.e. king blue-grass and bluegrass) and is most likely due to the exceptionally dry conditions, preceding, and at the time of the dry season surveys (Section 3).

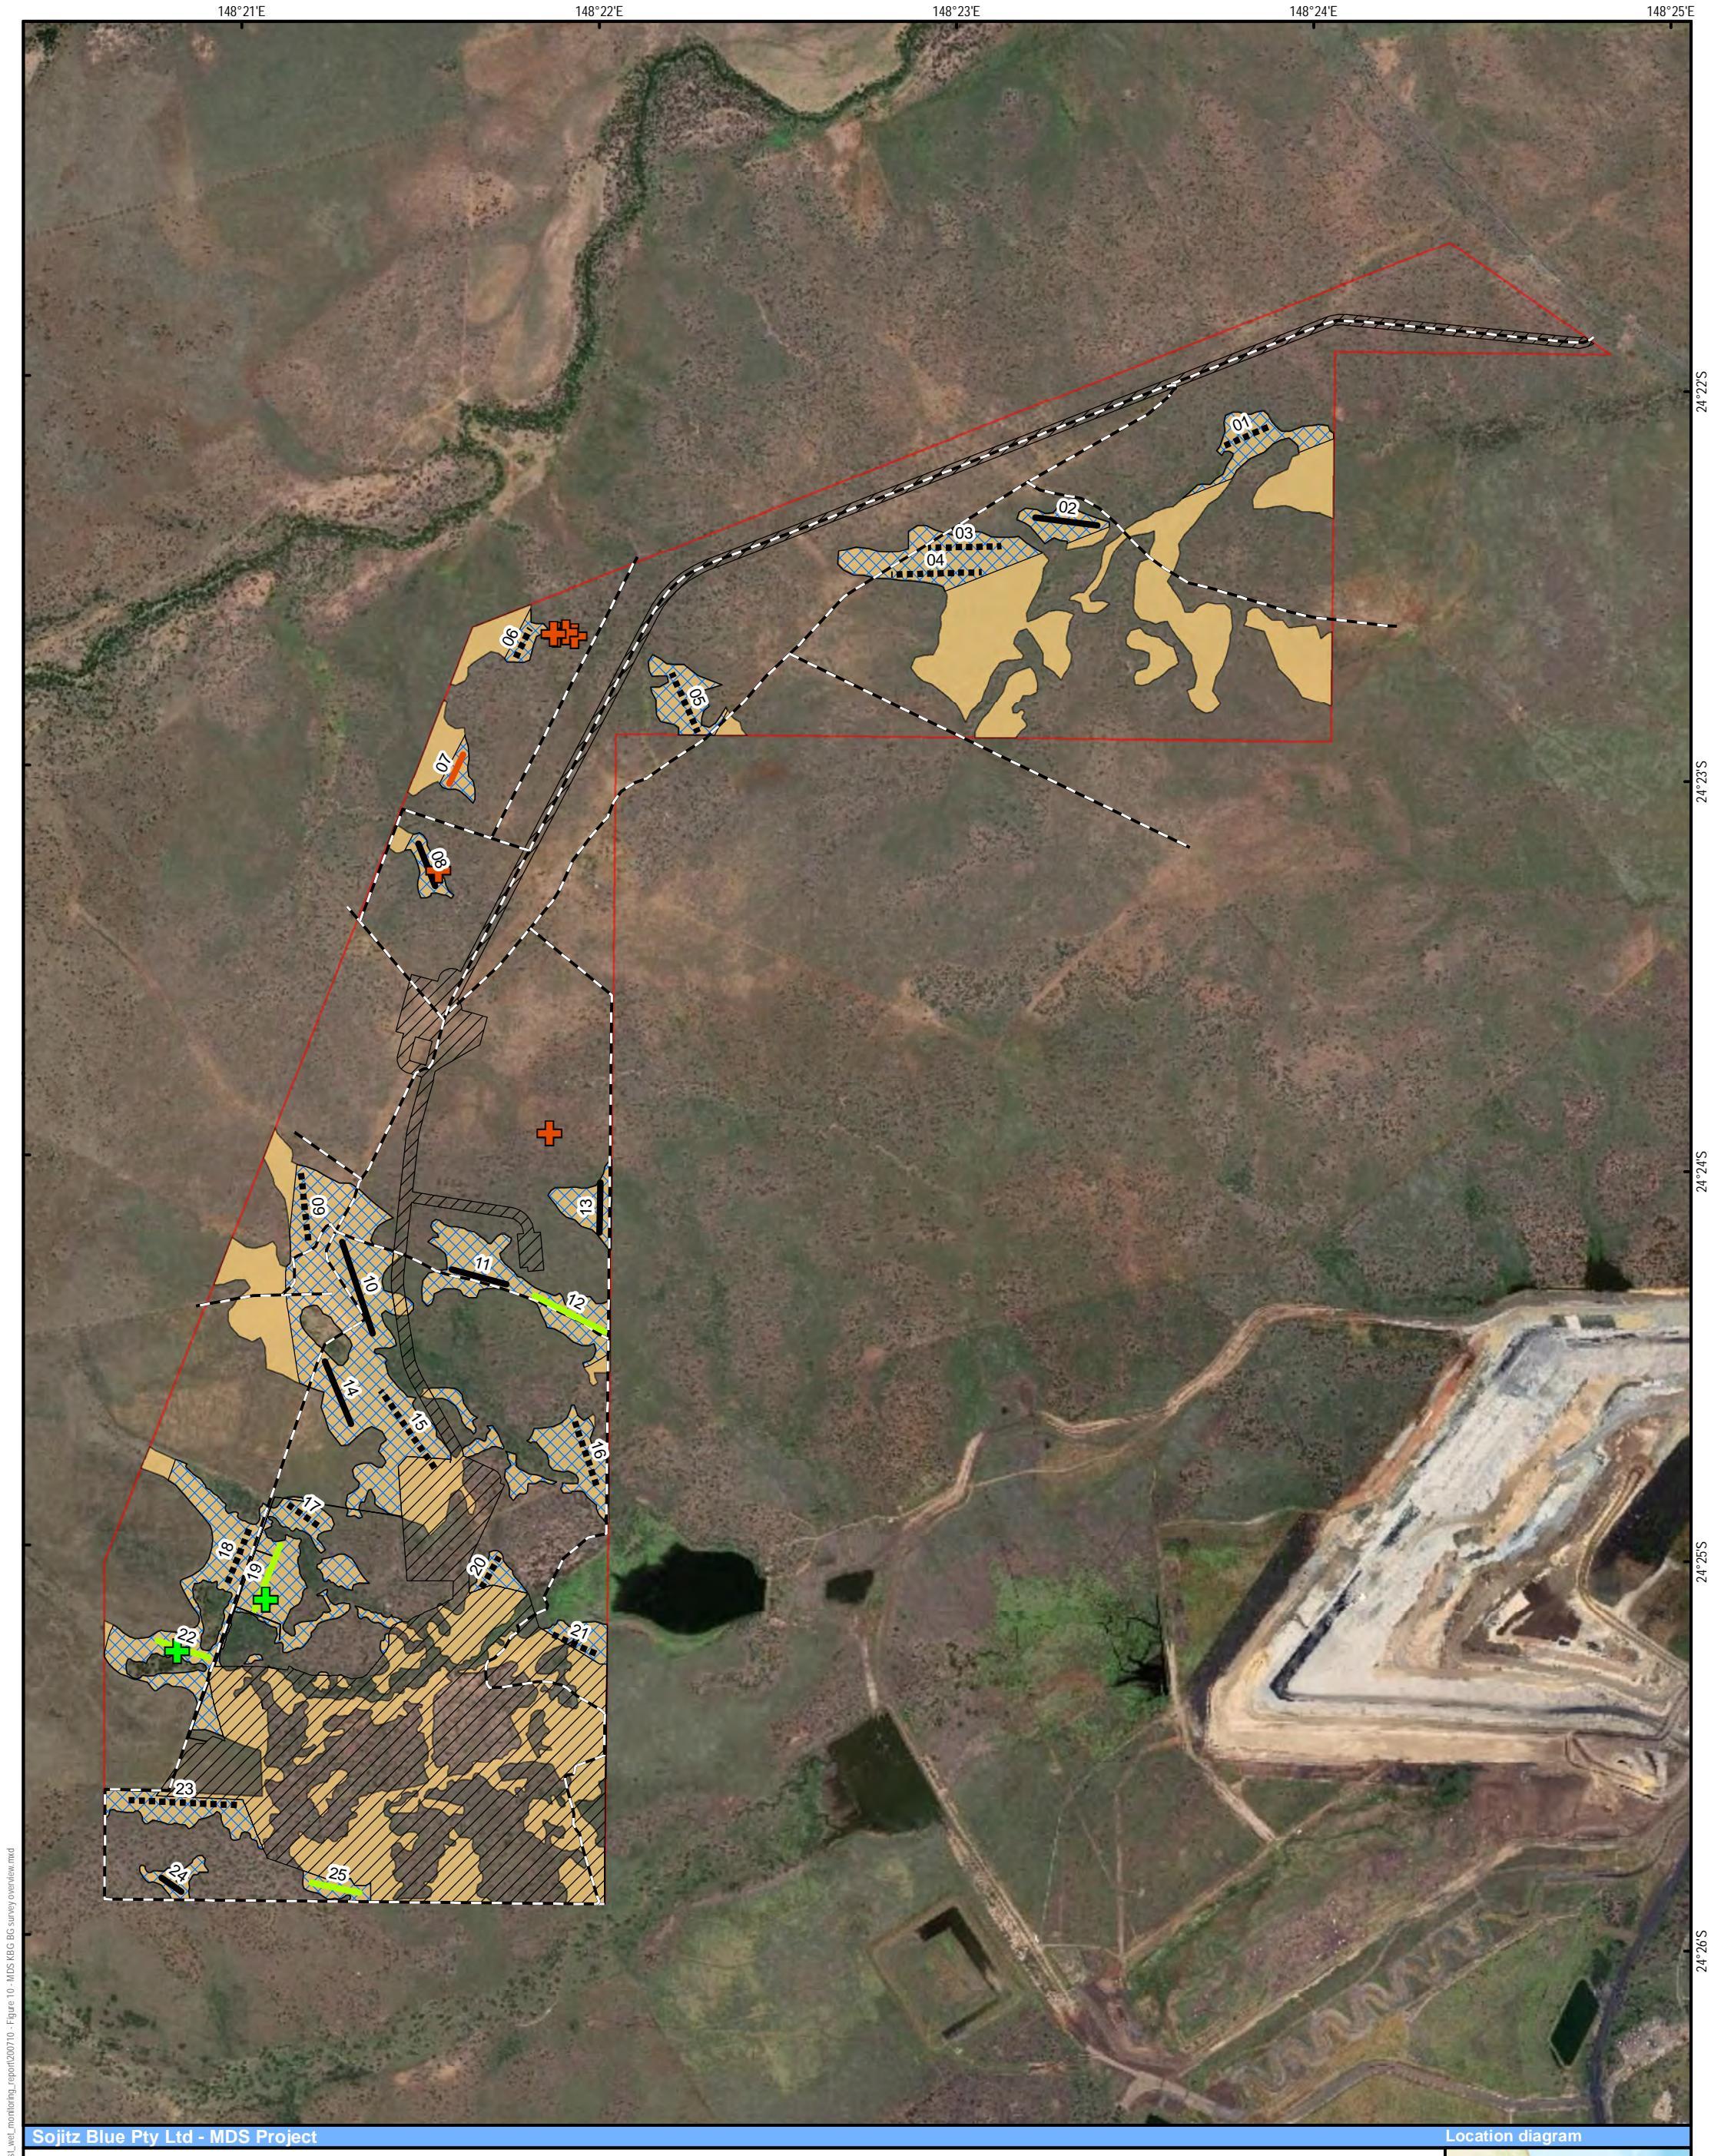
Figure 10 Location of king blue-grass and bluegrass recorded on the MDS Project site during the post-wet season surveys DATA SOURCE: The folowing datasets are © State of Qld: - Mining Lease The following datasets provided by Sojitz - Disturbance areas - Habitat for king blue-grass and bluegrass

Records of king blue-grass were confirmed from four of the 12 threatened grass survey transects (transect 12, 19, 22 and 25) (Table 7 and Figure 10 to Figure 12), with two incidentally recorded populations in the vicinity of transect 19 and 22 (Figure 11). Eight populations of king blue-grass were recorded along transect 25, where two populations were confirmed in 2018. A further five populations were confirmed from the three other transects, reflecting a total population size of 95-275 tussocks across the 13 populations in four transects. The two king blue-grass population observed outside of the targeted survey transects totalled 52 – 105 tussocks.

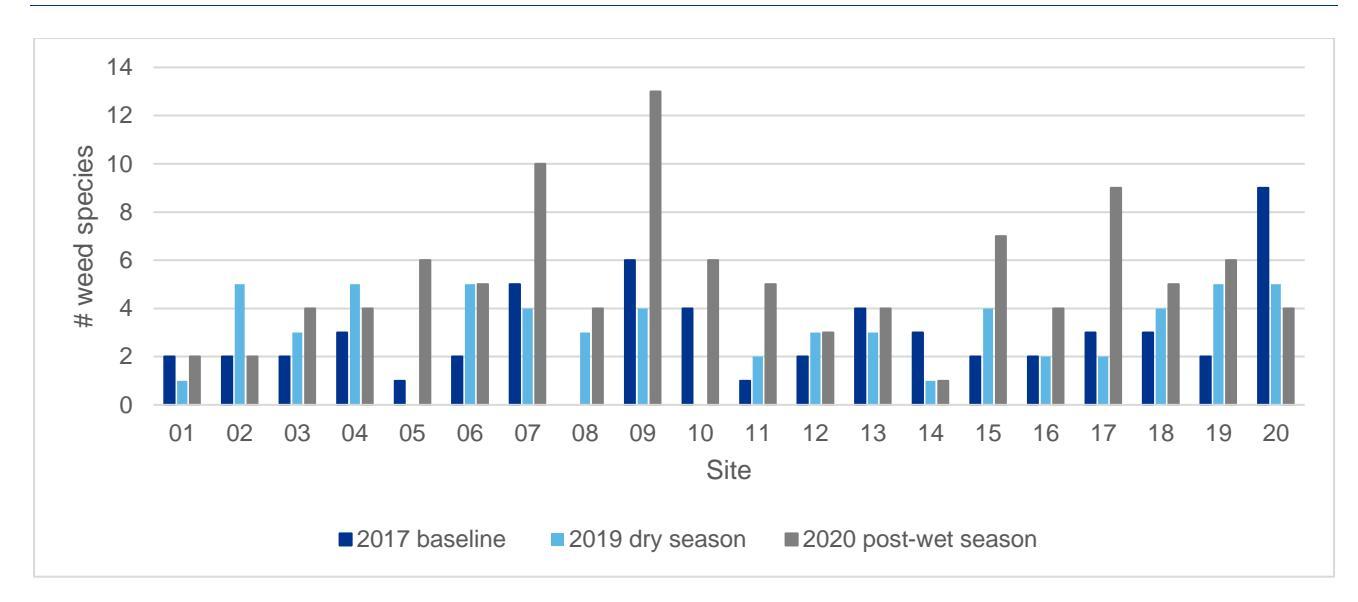
Figure 13: Number of weed species per site from the 2017 baseline, 2019 dry season and 2020 post-wet season surveys

Figure 13 and Figure 14 shows the number of weed species per site and percentage (%) weed cover per site from the three weed surveys undertaken to date. Most notably, the greatest number of weed species and weed coverage was recorded from Site 09 on the edge of Naroo Dam during the 2020 post-wet season surveys (13 species and 76% coverage). The most prelevant weed at this site was Lippia (*Phyla canescens*) which represented 42.8% of the weed coverage at the site. While not a prohibited or restricted invasive plant under the Queensland *Biosecurity* Act, lippia is a serios environmental and pastoral weed that is well adapted to riparian and floodplain environments (Department of Agriculture and Fisheries 2020). It forms a dense mat like ground cover and can outcompete both native and pasture species.

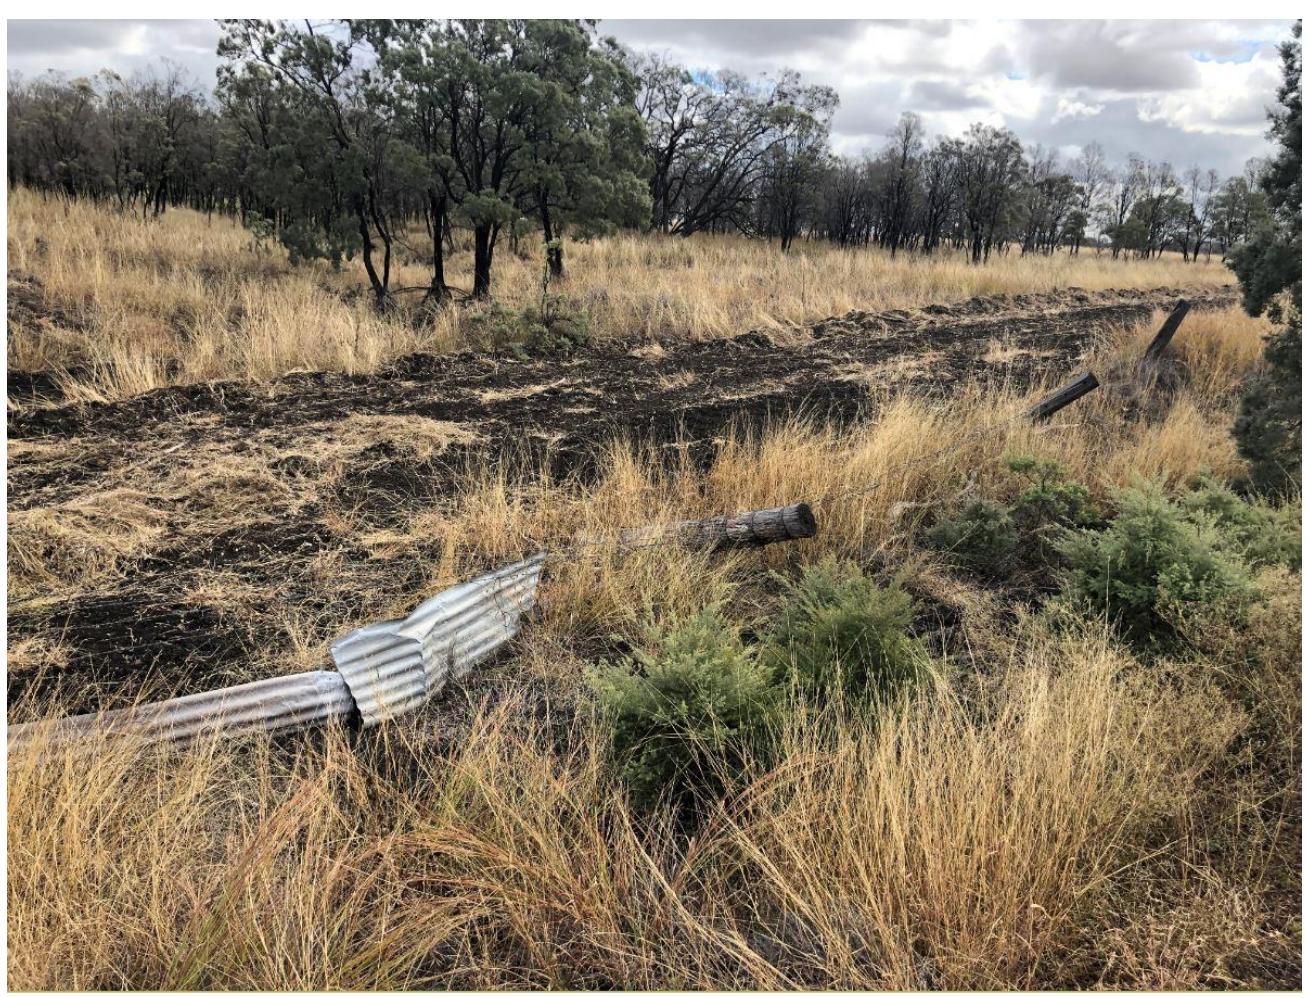
Figure 1: North-western boundary section of fence which requires maintenance.

Image 0009 in the GSI folder shows fence condition along the north-western boundary has worsened since the previous inspection – works required on fence.

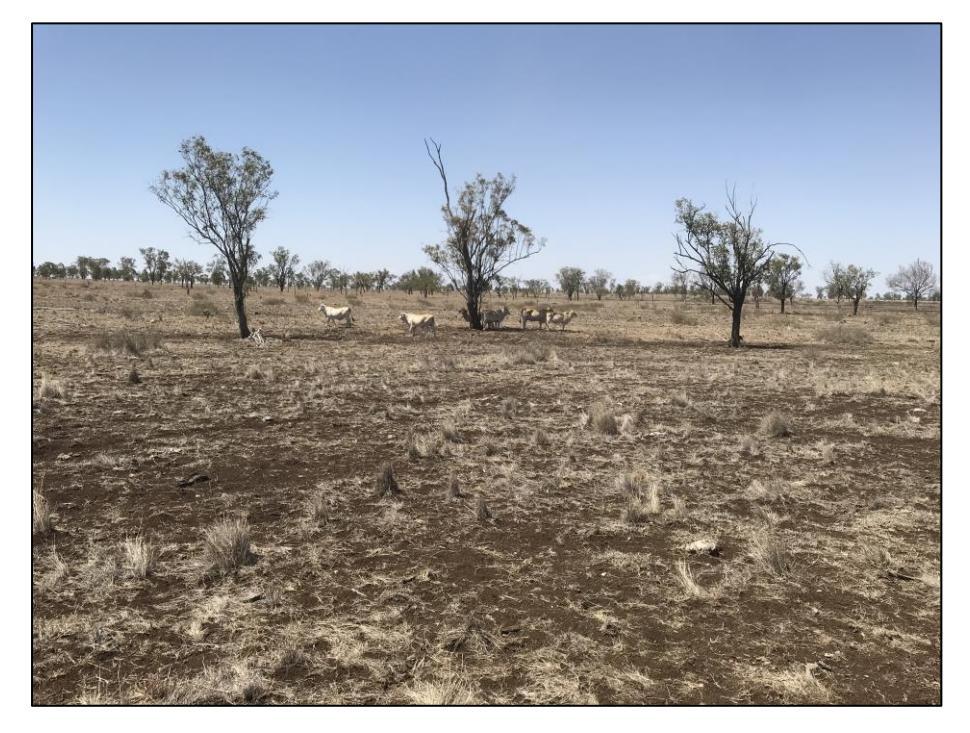
Figure 12: Overgrazing in the vicinity of W17, located within RE 11.8.11

Field investigations revealed that some areas appear to have been subject to overgrazing. In particular, the paddock containing weed monitoring plot W17 displayed a notable lack of groundcover (Figure 12) due to continued grazing during the drought period, with weeds such as *Parthenium hysterophorus* and *Vachellia farnesiana* contributing to a high proportion of the remaining cover. Notwithstanding, it is understood that MDS is responsible for the management of activities within the Project site only and does not have any responsibility for grazing regimes in the mining lease area that is outside of the Project site.

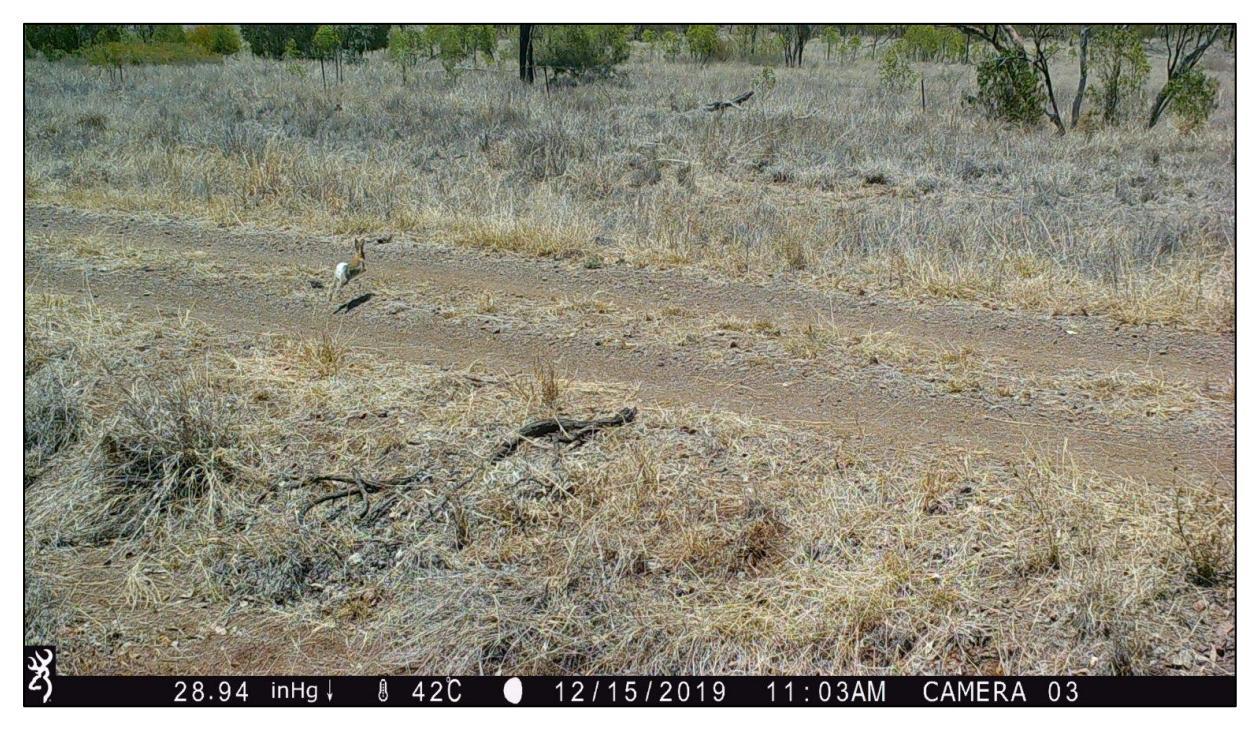
Figure 14: European rabbit (Oryctolagus cuniculus) captured on a fauna camera at Site C12 at Lexington.

Results of rabbit monitoring confirmed the presence of rabbit/hare scats from all 10 rabbit monitoring plots (R01 – R10) (Figure 15). Across these plots, pellet abundance ranged from isolated pellets and small clumps more than 10 m apart, to abundant pellets, often in large clumps and buck-heaps. Brown hares (*Lepus europaeus*) and European rabbits (*Oryctolagus cuniculus*) (Figure 14) were also visually confirmed by six separate fauna camera stations (Site C03, C09, C10, C12, C13, C15), which were spread evenly across the whole site. Brown hares were found to be more abundant, with eight captures recorded across five cameras on three separate nights, as opposed to only two rabbit sightings on one night.

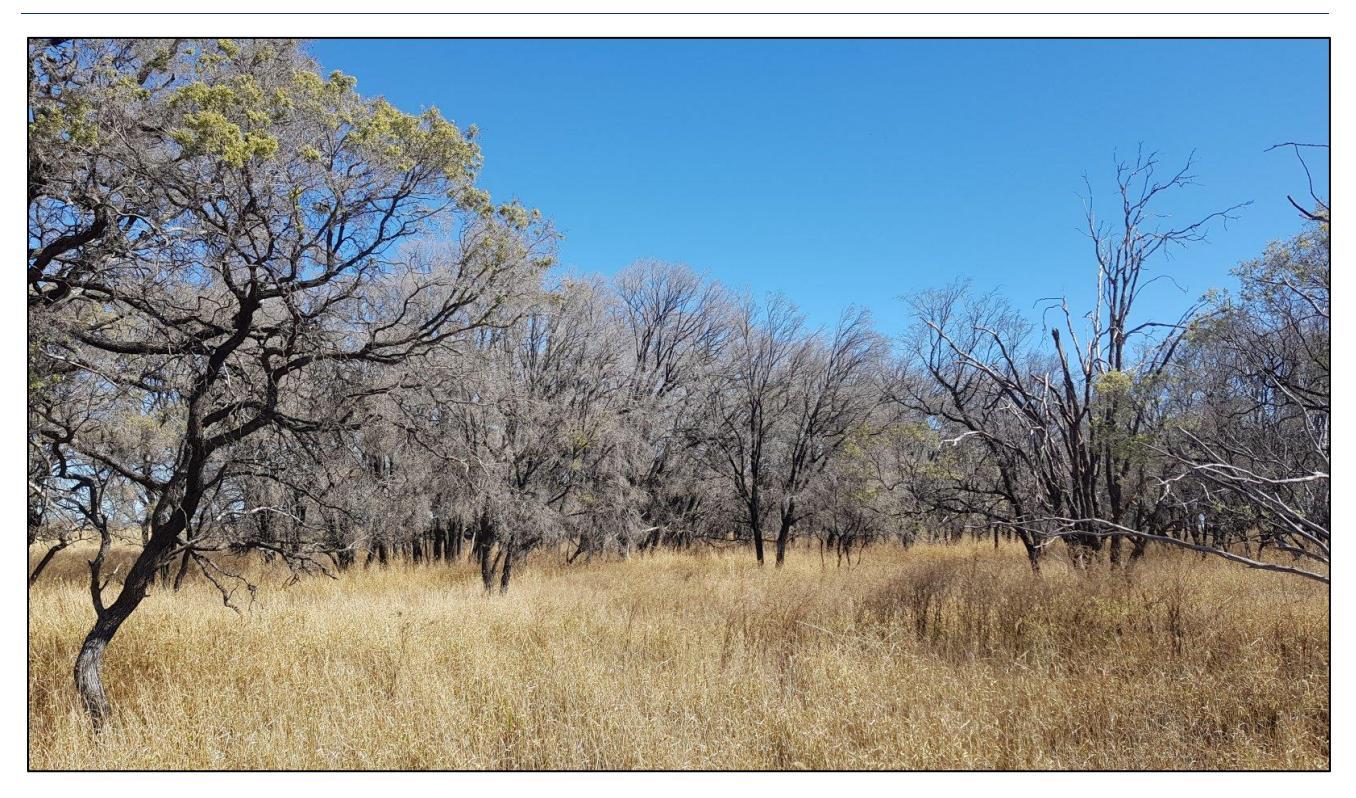
Figure 21: Evidence of dieback of *Melaleuca bracteata* in areas of RE 11.8.11a.

- Areas of 11.8.11a in the south-west of the MDS Project site appeared to be under stress with the majority of *Melaleuca bracteata* in these areas showing signs of dieback (Figure 5), most likely as a result of the very dry conditions at the end of 2019. Epicormic regrowth however was observed on this vegetation community at the time of the post-wet season surveys in June 2020 indicating that the vegetation community was in a state of recovery.
